Edington (Shapwick and Catcott) Infiltration Reduction Plan

Summary

April 2021 – March 2022

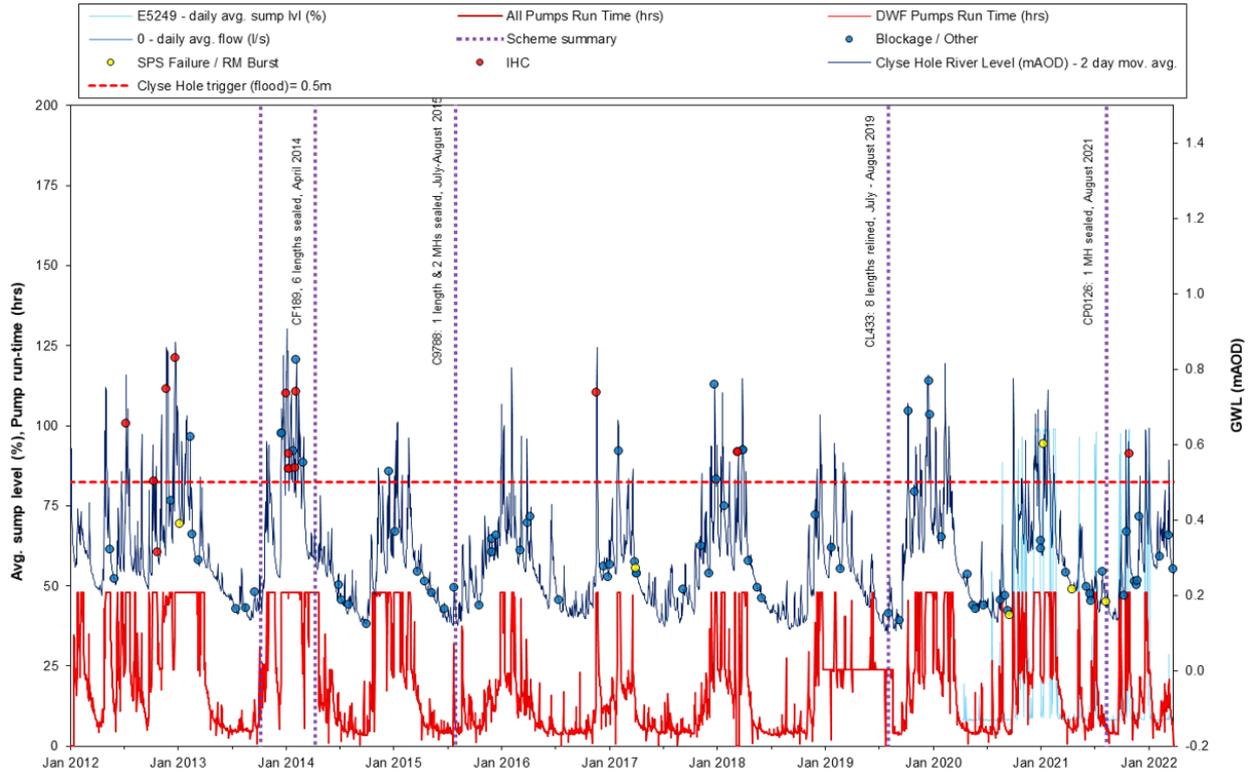
Edington, Catcott & Shapwick Incidents vs. Clyse Hole River Level vs. 14585 Broadmead Lane (Som) SPS

This graph shows incidents against river level (as measured at Clyse Hole river gauge) and the telemetry at Edington Sewage Pumping Station (SPS). Although extensive sewer rehabilitation has been completed, infiltration is still evident in the catchment, demonstrated by the fact the wet well at Edington SPS is still high for prolonged periods of time in the winter months. However, there has been a significant decrease in reported incidents in the years since, with only one flooding reported due to inadequate hydraulic capacity (IHC) in November 2021.
