Primrose Drive, Melksham Infiltration Reduction Plan Summary

This provides an update on the last year's groundwater situation, what mitigation actions, if any, were taken and a summary of our action plan to prevent flooding due to groundwater infiltration of our sewer network.

April 2021 – March 2022

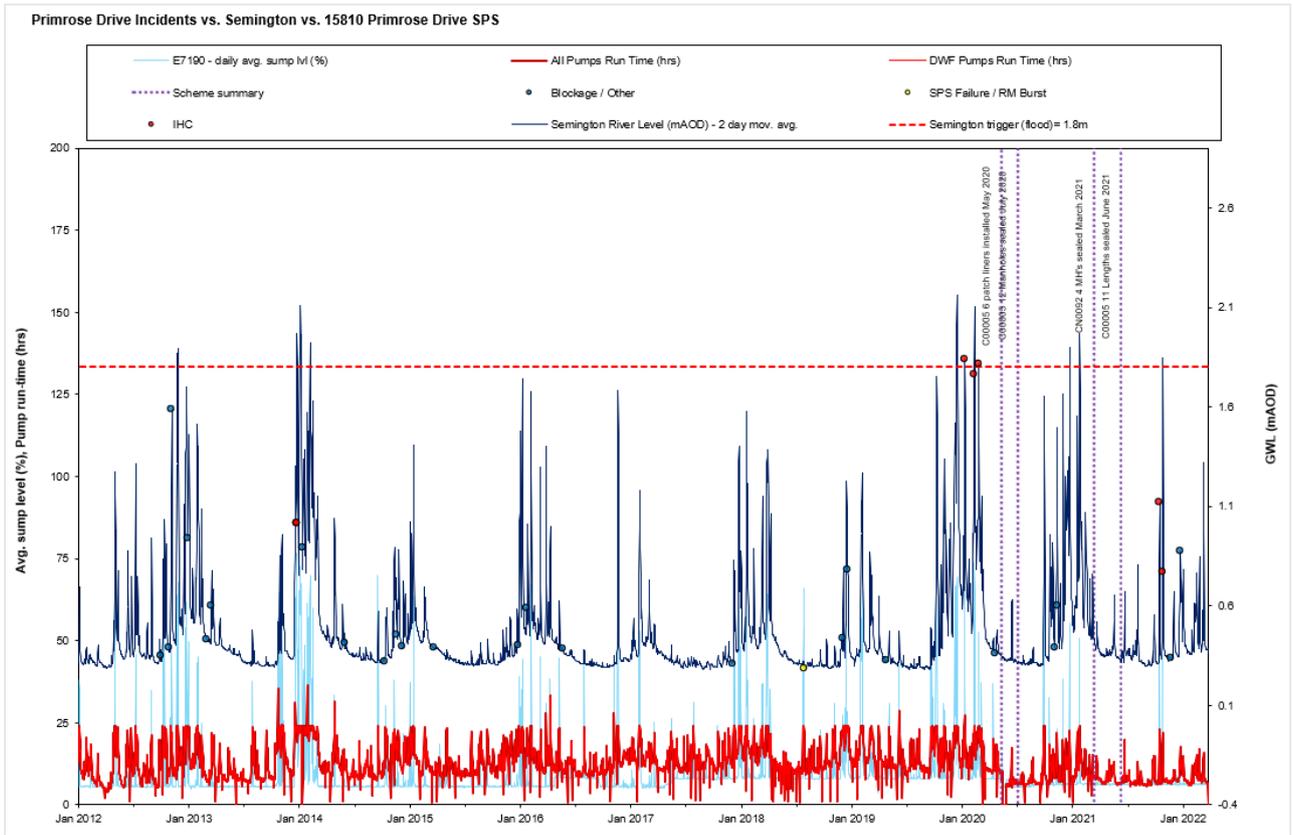
This graph shows incidents against river level (as measured at Semington) and the telemetry at Primrose Drive SPS. Sewer sealing has taken place in 2021. Two incidents attributed to inadequate capacity were reported in October 2021 following heavy rain, the wet well level at the SPS was high at the times of these incidents with the pumps responding well.
