## Barton Lane Infiltration Reduction Plan Summary

### April 2019 – March 2020

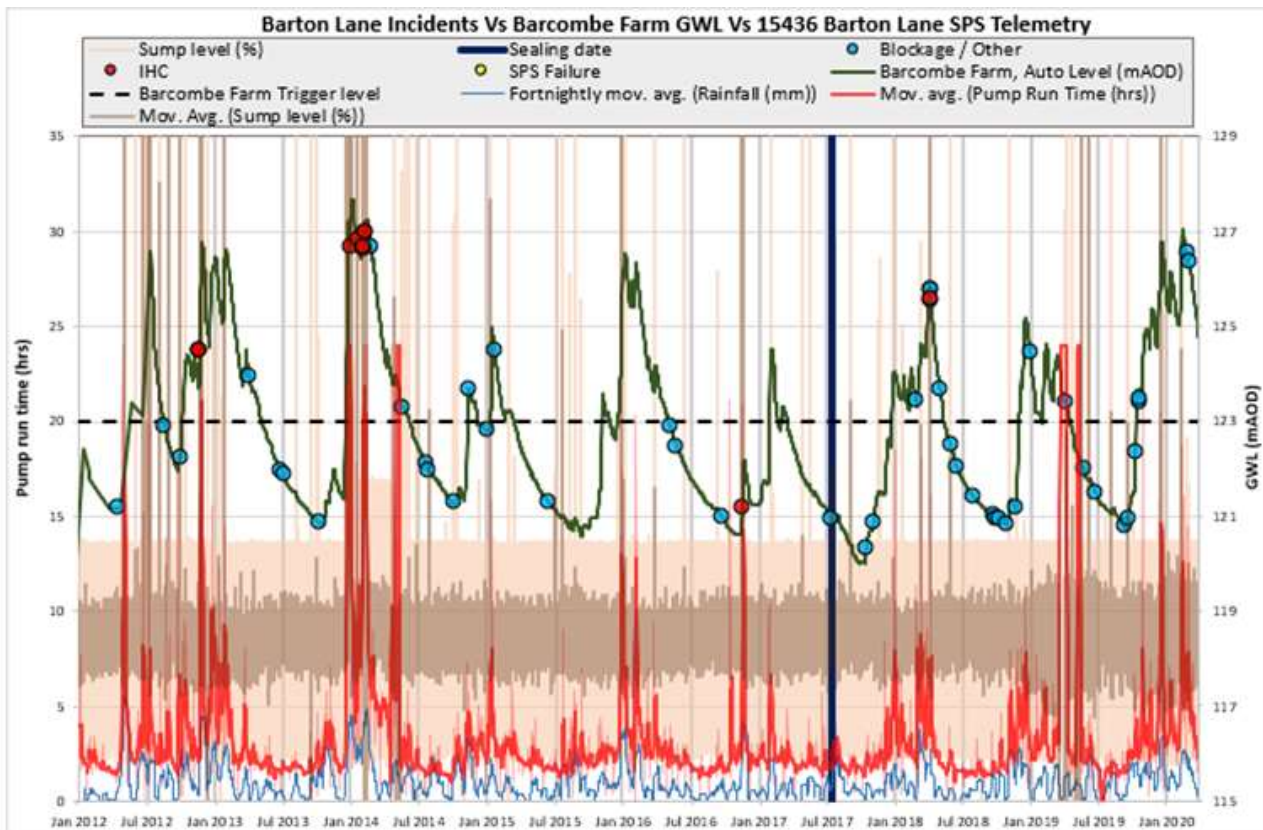
This graph compares incidents against regional groundwater level (as measured at Barcombe Farm borehole) and the flow at Barton Lane Sewage Pumping Station (SPS), Ruishton. Prior to the sewer sealing, there was a strong correlation between the groundwater level and the flow at Barton Lane. Post sealing this relationship has reduced but is still visible. The last recorded incident due to inadequate hydraulic capacity (IHC) was recorded in April 2018, whilst groundwater levels were high and during severe weather.

During the exceptionally wet winter of 2019 /2020 the ground water level reached critical levels. The pumps at Barton lane SPS coped with the increased inflow and the only incidents recorded were due to blockages.
