## Bleadon Infiltration Reduction Plan Summary

### **April 2021 – March 2022**

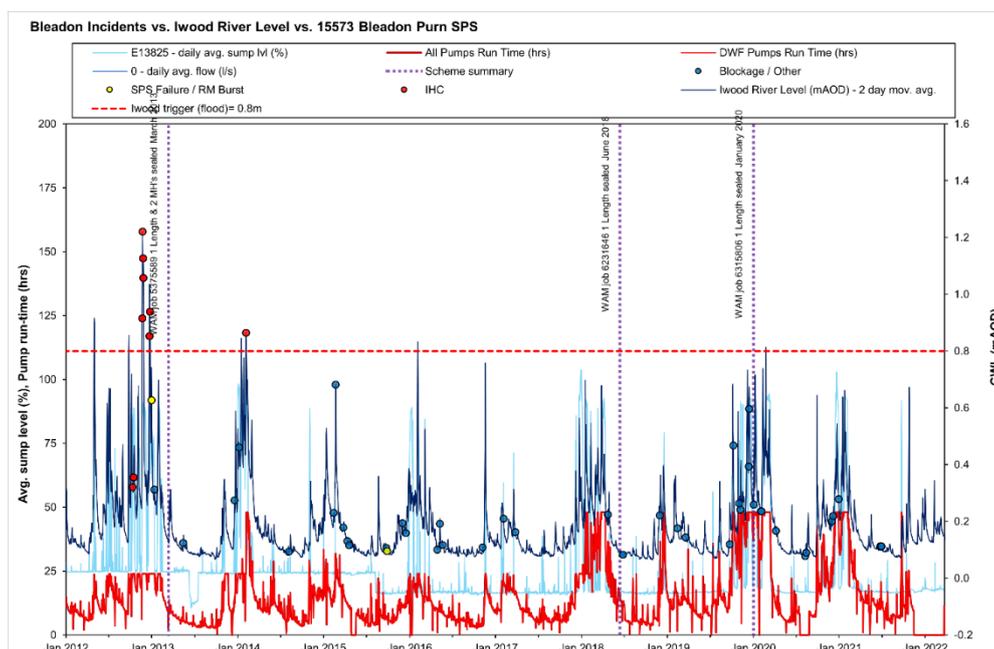
The graph below compares the Iwood River level and telemetry at Bleadon Purn SPS. The river level is used to indicate groundwater levels in the area. This winter has seen much lower river levels than previous winters and no incidents due to IHC have been reported. Pump activity at the SPS was disrupted during the winter while works were completed to install flow monitors.
