Cromhall Infiltration Reduction Plan Summary

April 2019 – March 2020

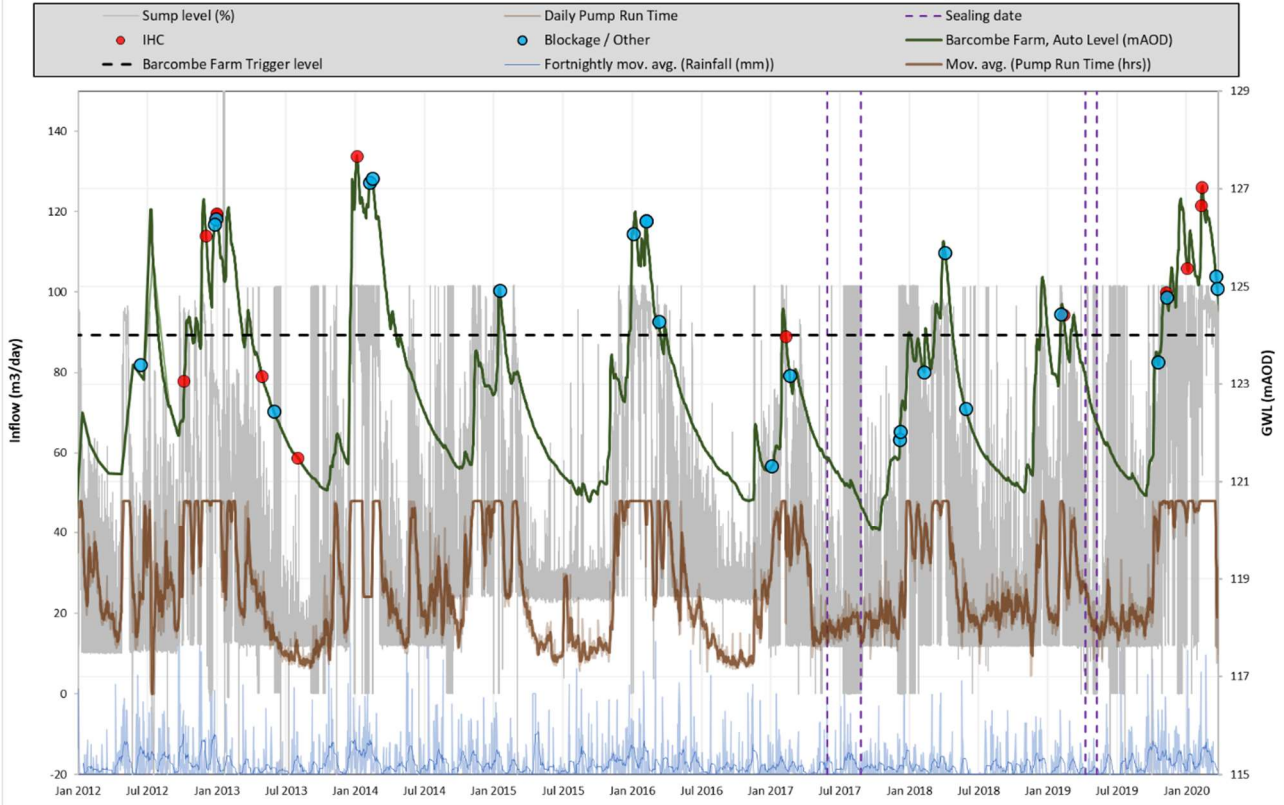
Cromhall Incidents Vs Regional GWL Vs Townwell SPS 15163 Telemetry

This graph shows incidents against regional groundwater level and telemetry at Townwell SPS. Prior to the sewer lining in July 2017, to prevent infiltration, there was a strong correlation between groundwater levels and the sump/ pump run times. Post sealing, the reported flooding incidents in Townwell remained low during 2018/19. However, groundwater levels in 2019/20 reached very high peaks, like those experienced in 2014. There remains a strong correlation between the rise in groundwater levels and incidents attributed to inadequate hydraulic capacity (IHC).
