Sydling St. Nicholas Infiltration Reduction Plan Summary

April 2019 – March 2020

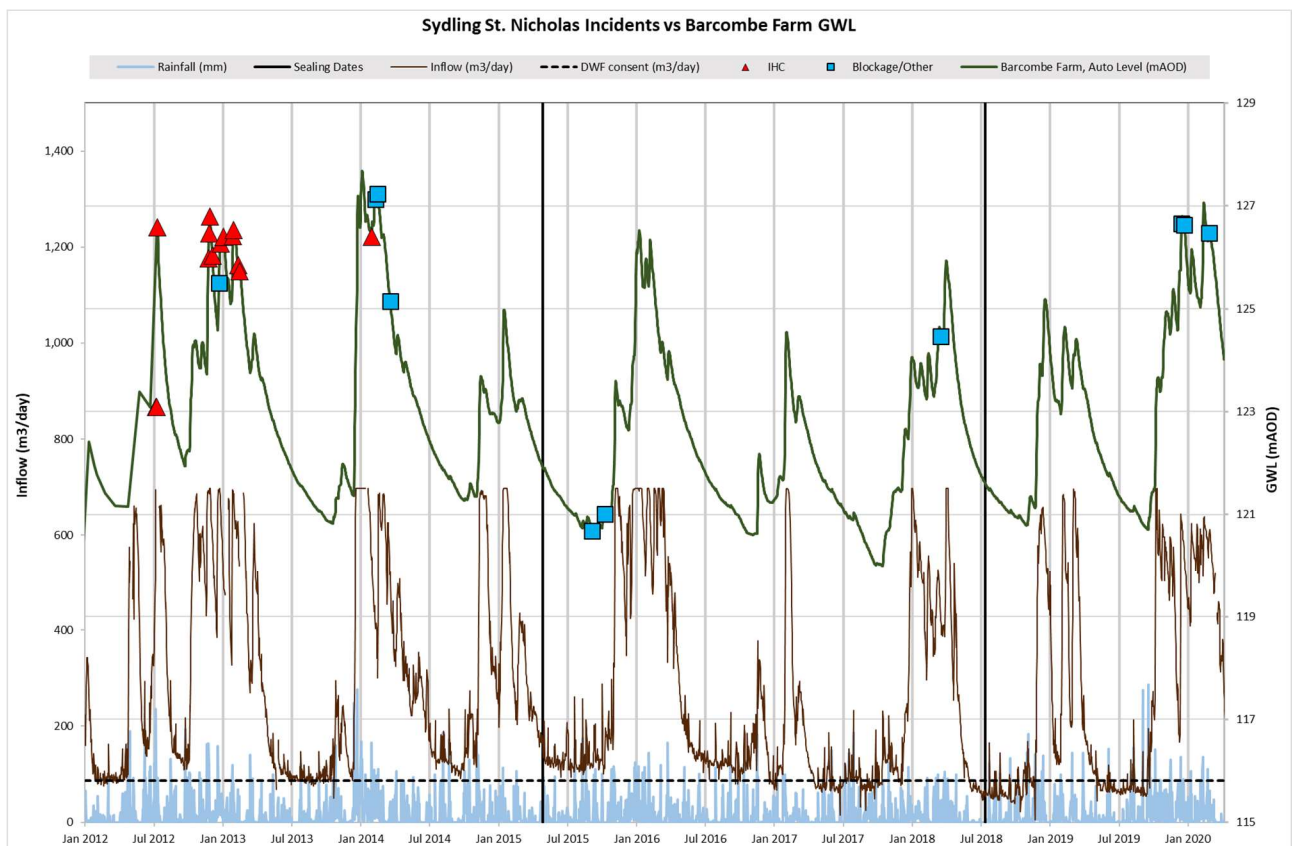
This graph shows incidents against groundwater level (as measured at Barcombe Farm borehole) and the flow at Sydling St Nicholas Water Recycling Centre. In the Sydling St Nicholas catchment there is a strong correlation between the inflow and the groundwater levels indicating that this area suffers from infiltration. Since the sealing in March 2015 there is still a strong correlation however the number of insufficient hydraulic capacity (IHC) incidents has decreased significantly.
